CATHODIC PROTECTION SYSTEM

FOR FLEET MOORINGS

CATHODIC PROTECTION SYSTEM FOR FLEET MOORINGS

Technical Report R-702

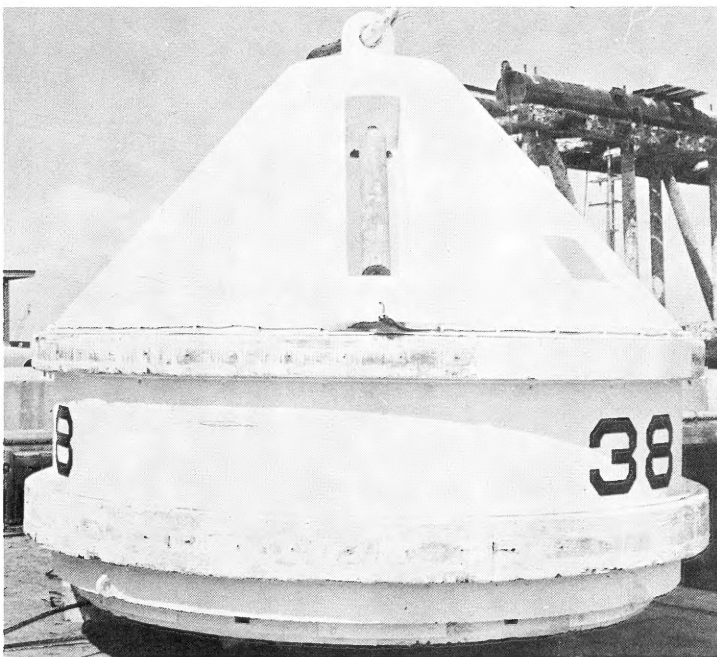
Figure 4. Inverted test buoy showing the square-foot area of bare steel on lower left of cone and location of the ground cables.

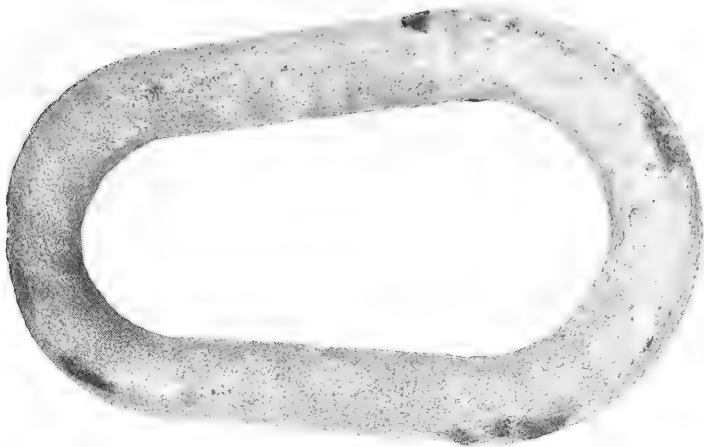
The total cost for rehabilitation of the control mooring amounted to \$4,617 of which \$2,000 was for pickup and installation and \$2,617 was for repairs. The unprotected ground ring assembly was loose, and all rivets needed replacing. The pear links were badly pitted, and the thickness was reduced in places to 1-1/2 inches (a loss of 40%), necessitating their replacement (Figure 13). The chain thickness for the first five links on all legs had been reduced to about 1-7/8 inches.

Figure 13. Pear link from control mooring showing pitting and greatly reduced thickness.

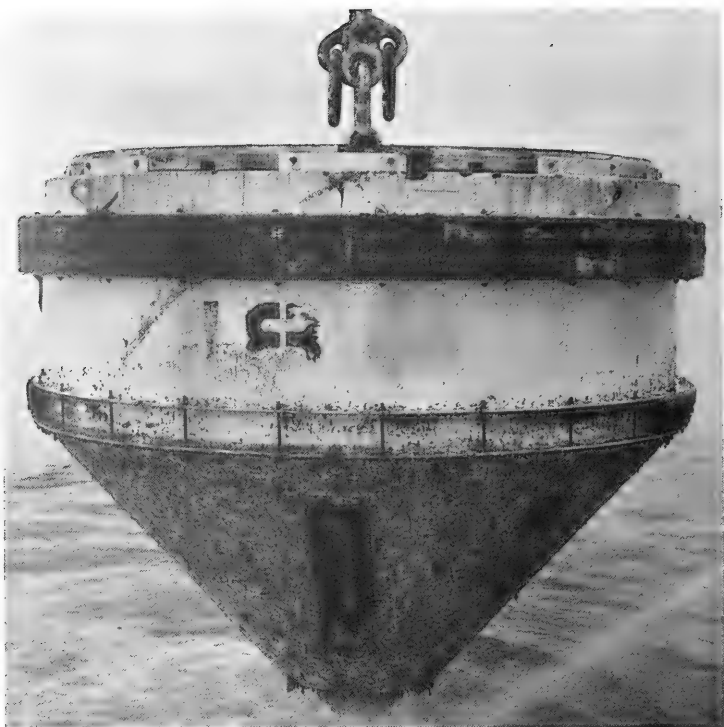
Twenty-three months after relocation of the cathodically protected mooring, the buoy was lifted from the water for its annual inspection. The buoy and the entire riser-chain was hosed with seawater (Figure 16) to remove the attached fouling organisms. The buoy had lost about half of its lower fender from marine borer attack. There was very little coating damage

(mostly from abrasion) and no detectable rusting of steel below water except for the square of exposed steel that had a hard tight film of rust but no pitting or active corrosion. Rather heavy marine fouling had accumulated since the buoy was washed 1 year earlier. Fouling included tunicates, barnacles, green algae, mussels, and tube worms.

Figure 16. Cleaned buoy 23 months after relocation. Note the lost section of lower fender, the anode in the sea chest, and the square of bare steel.

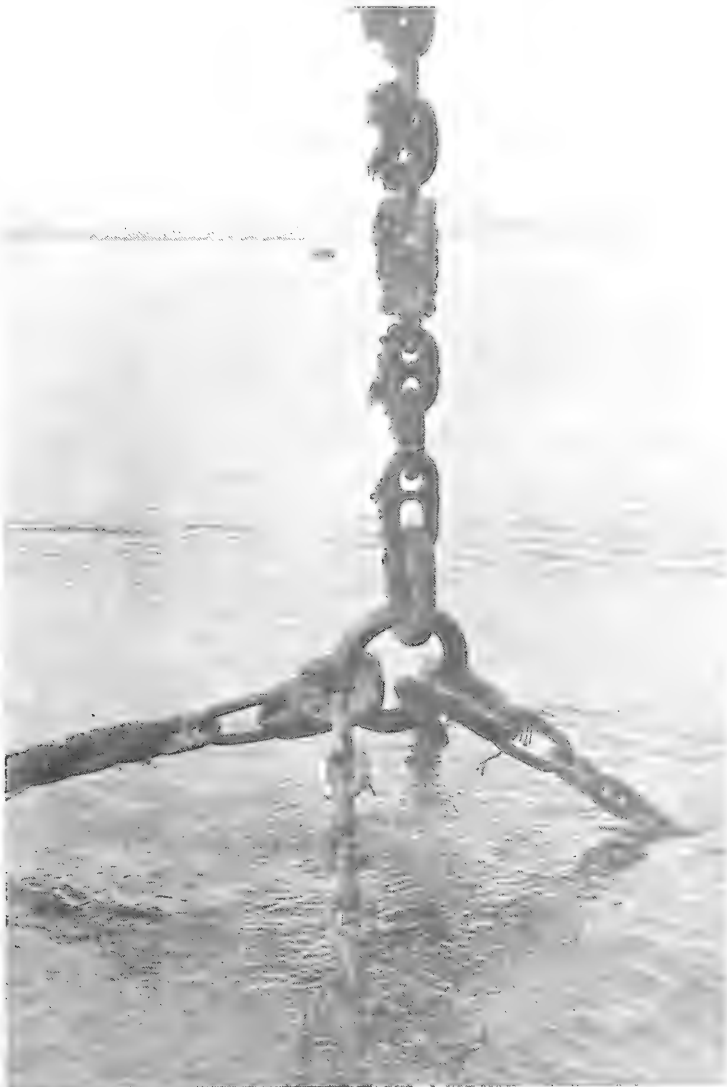
About one-third of the zinc anodes in the sea chests had been lost, and only about one-tenth of the zinc anodes on the riser-chain (Figure 17) had been lost. The divers who assisted in measuring the potentials indicated that the anodes on the ground legs were in a similar condition.

The riser-chain and ground ring assembly were in excellent condition (Figure 17) with no apparent corrosion. The chain diameter remained at 2-1/2 inches. The ends of the four steel cables that terminated near the ground ring had been pulled loose from their connections to the chains. Welds had been broken from two of the legs, and the cables had been pulled from the cable clamps that remained on the other two legs. This area still had sufficient electrical continuity for complete cathodic protection.

Figure 17. Ground ring assembly and riser-chain with anode 23 months after relocation.
